„Side-arms and floodplains along large rivers”
LIFE+ project closing conference
18-19 November 2013, Mohács, Hungary

Background, goals and experiences of habitat reconstructions in Gemenc

Dr. Tamás Enikő Anna CE, PhD

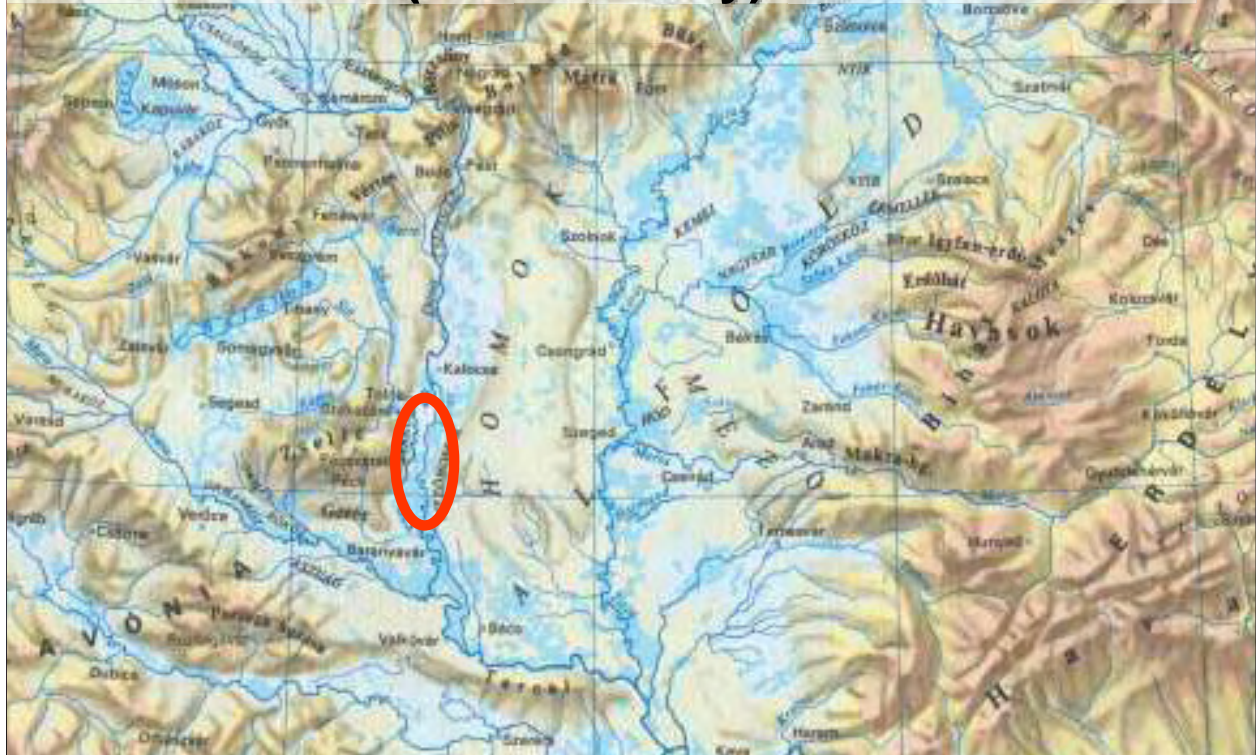
Hungary before river regulation (17th century)

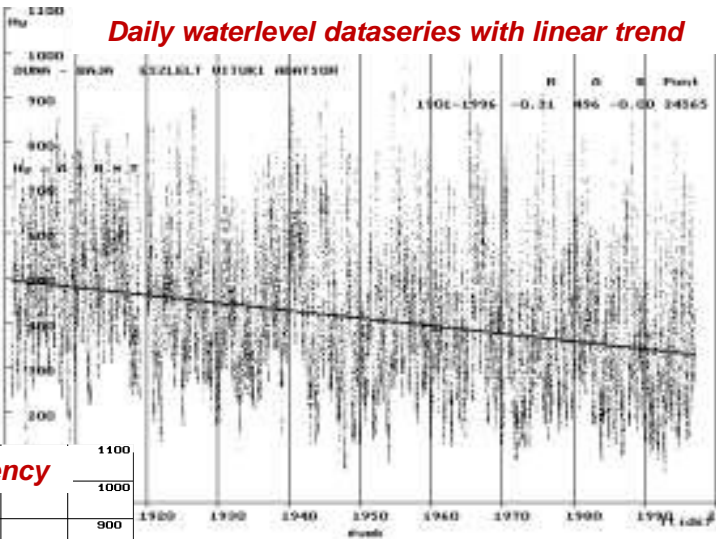
Daily waterlevel dataseries with linear trend

- Second half of the 1980's: first signs of „drying” of Danube floodplains recognized
- As floodplain water regime is determined by Danube, the first analysis of Danube dataserie between 1901-1990 took place (*Kalocsa-Zsuffa sr., 1992*)
- Statistical analysis of Danube waterlevel dataserie shows unambiguous decrease of long-term trends – but there is no evident change in discharges
- Suspected reason for an increased erosion is regulation in the end of 19th and beginning of 20th century, i.e. the increase of slope and thus sediment transport capacities
- As annual minimal stages on the reach dropped lower than ever in the beginning of the 2000's, new investigations were done, which gave evidence of increased erosion (*Tamás 2006*)

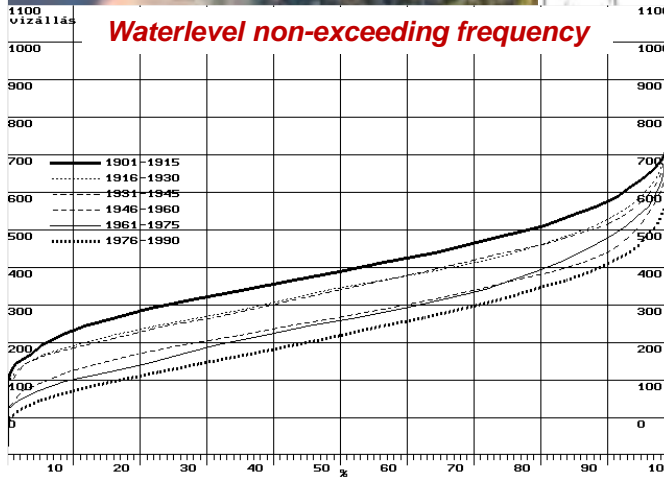
Waterlevel non-exceeding frequency

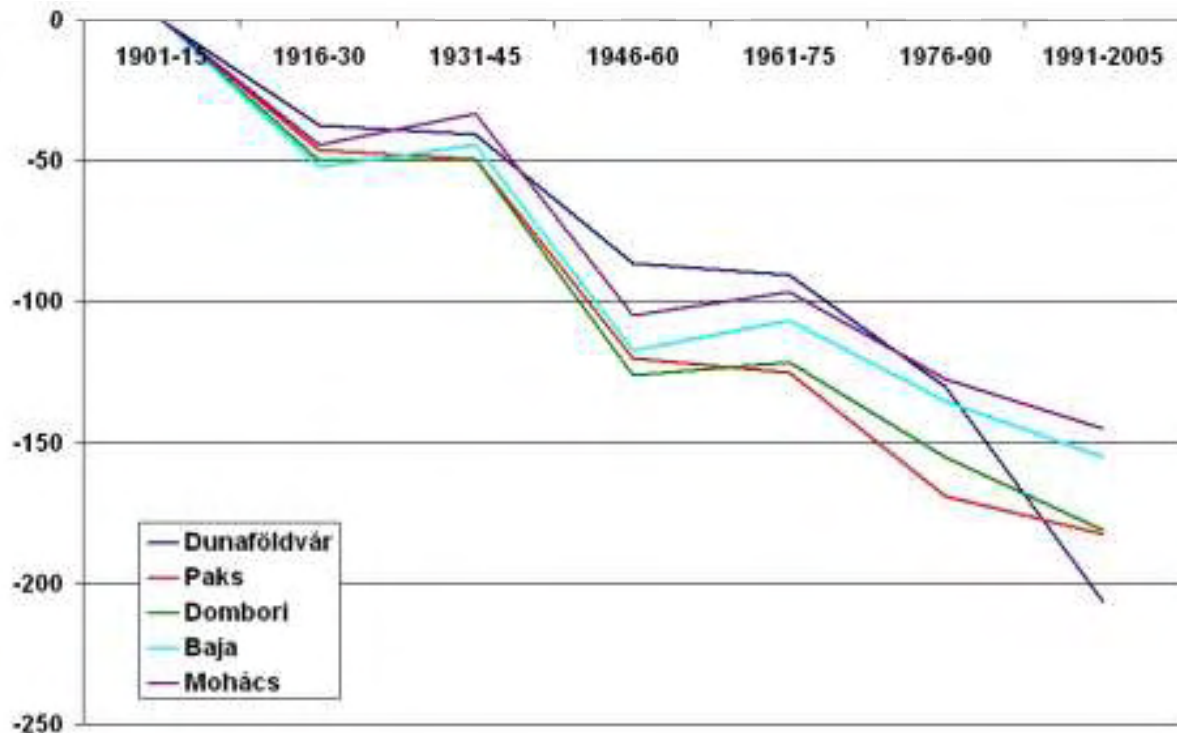
Speed of erosion, 15-year periods, 1901-2005

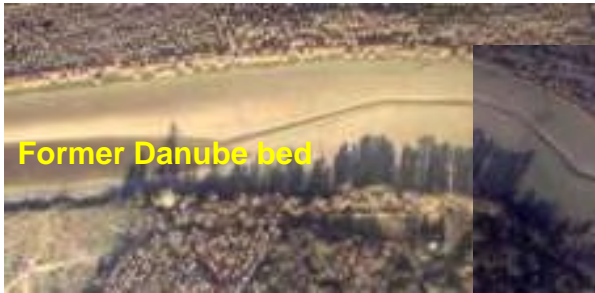
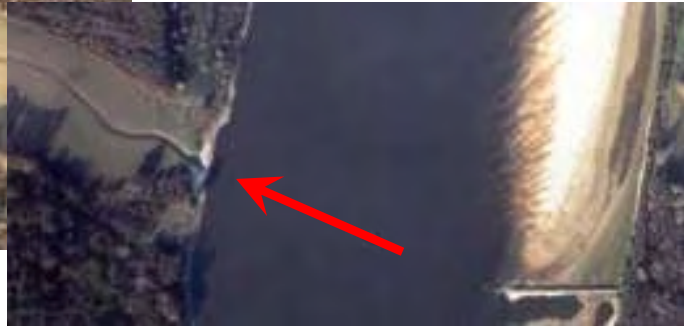
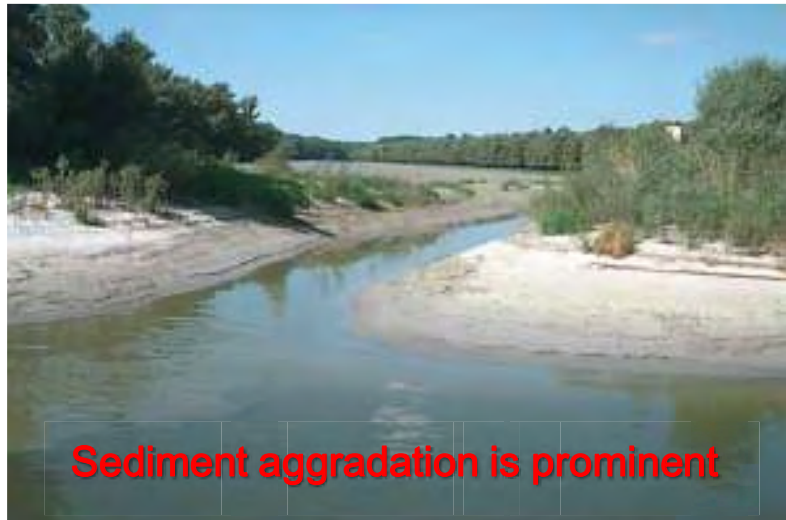
Problems in big side branches: Grébec branch

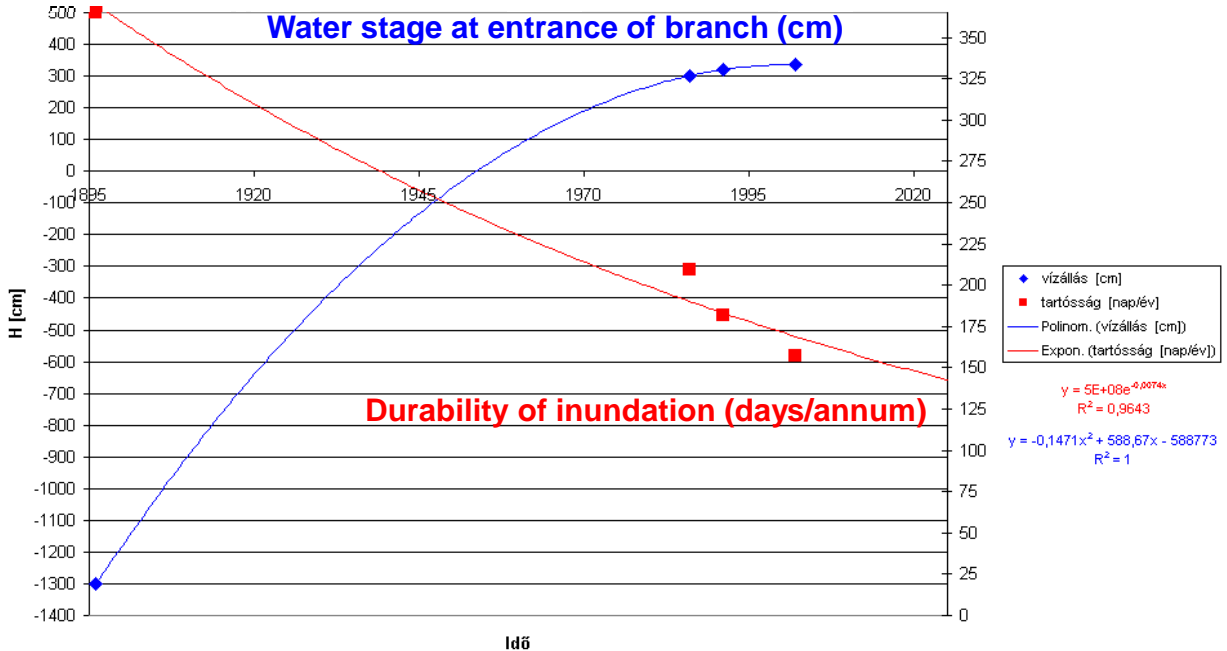
Sediment aggradation is prominent

The higher the aggradation, the bigger stage is needed for inundation – changes over 110 years:

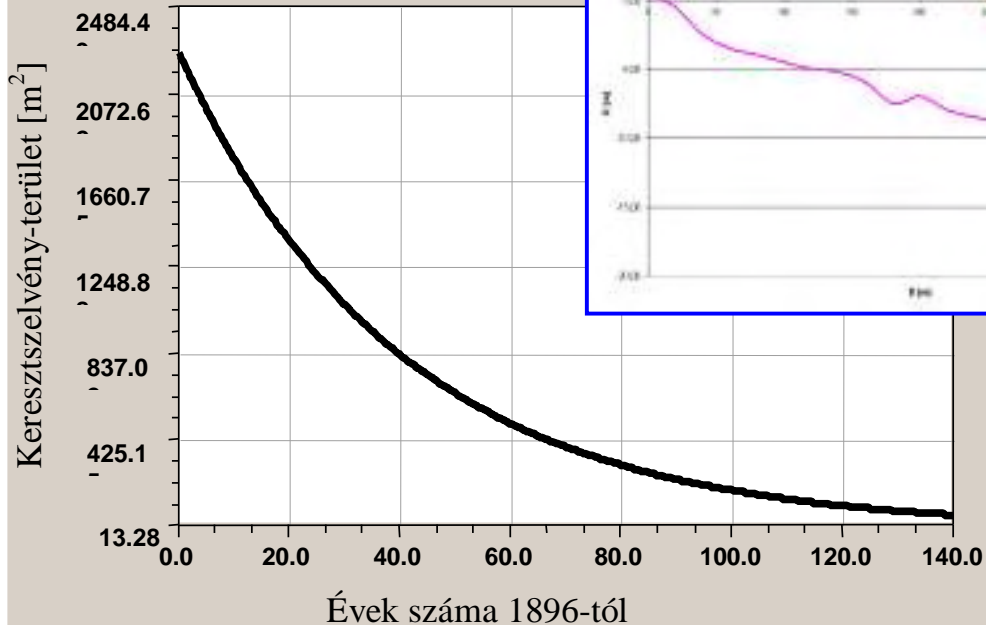
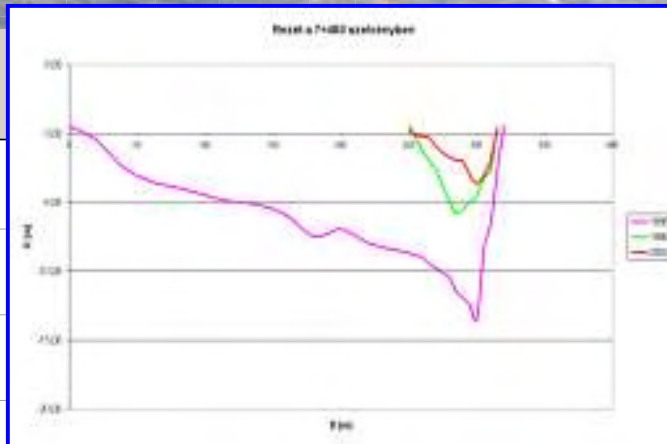
Decrease of cross-section areas – Rézét branch

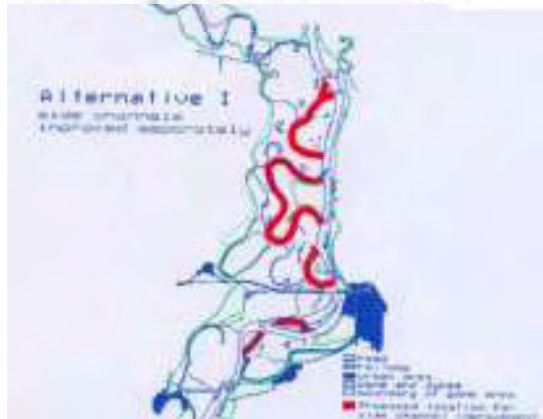
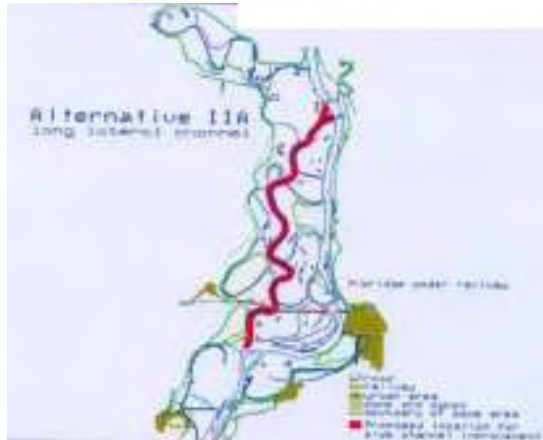
Proposed water supply improvement solutions, 1992

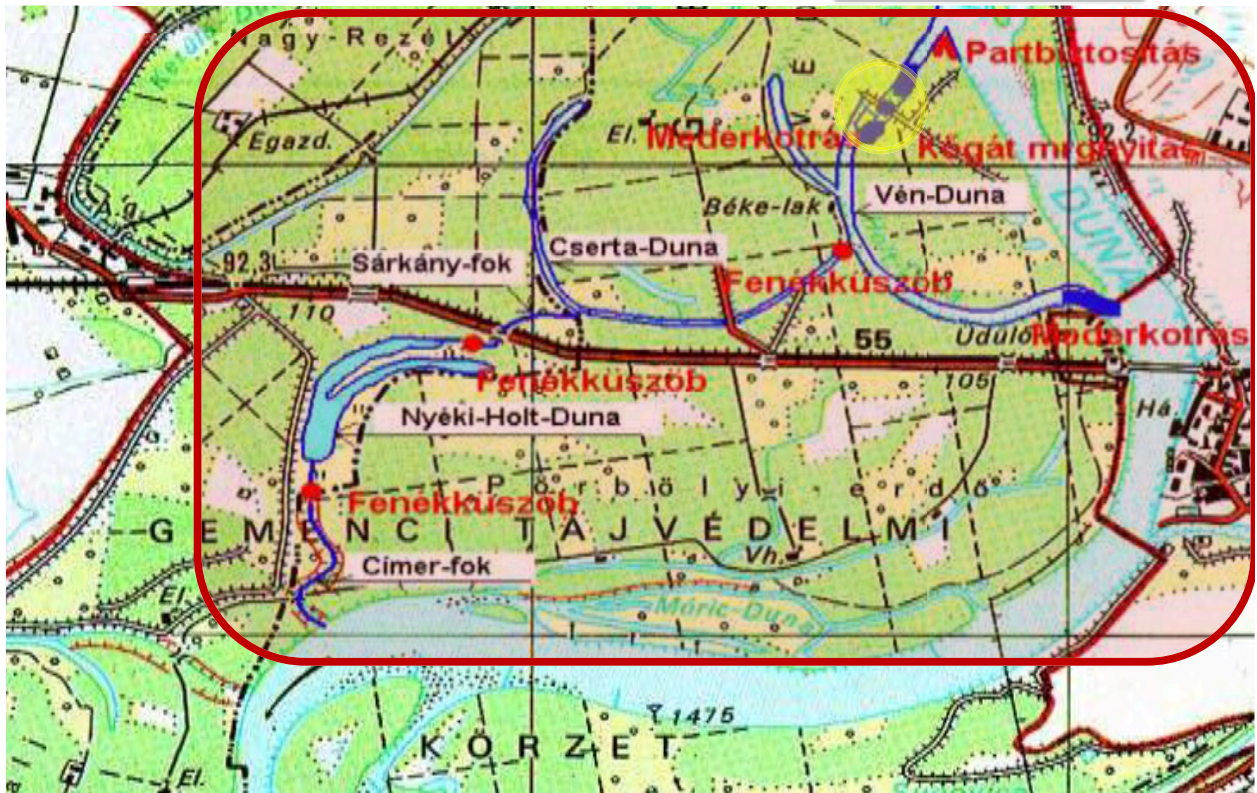
Vén-Duna – Cserta – Nyéki reconstruction works, 1998-1999.

1480,8 - 1483,5 fkm

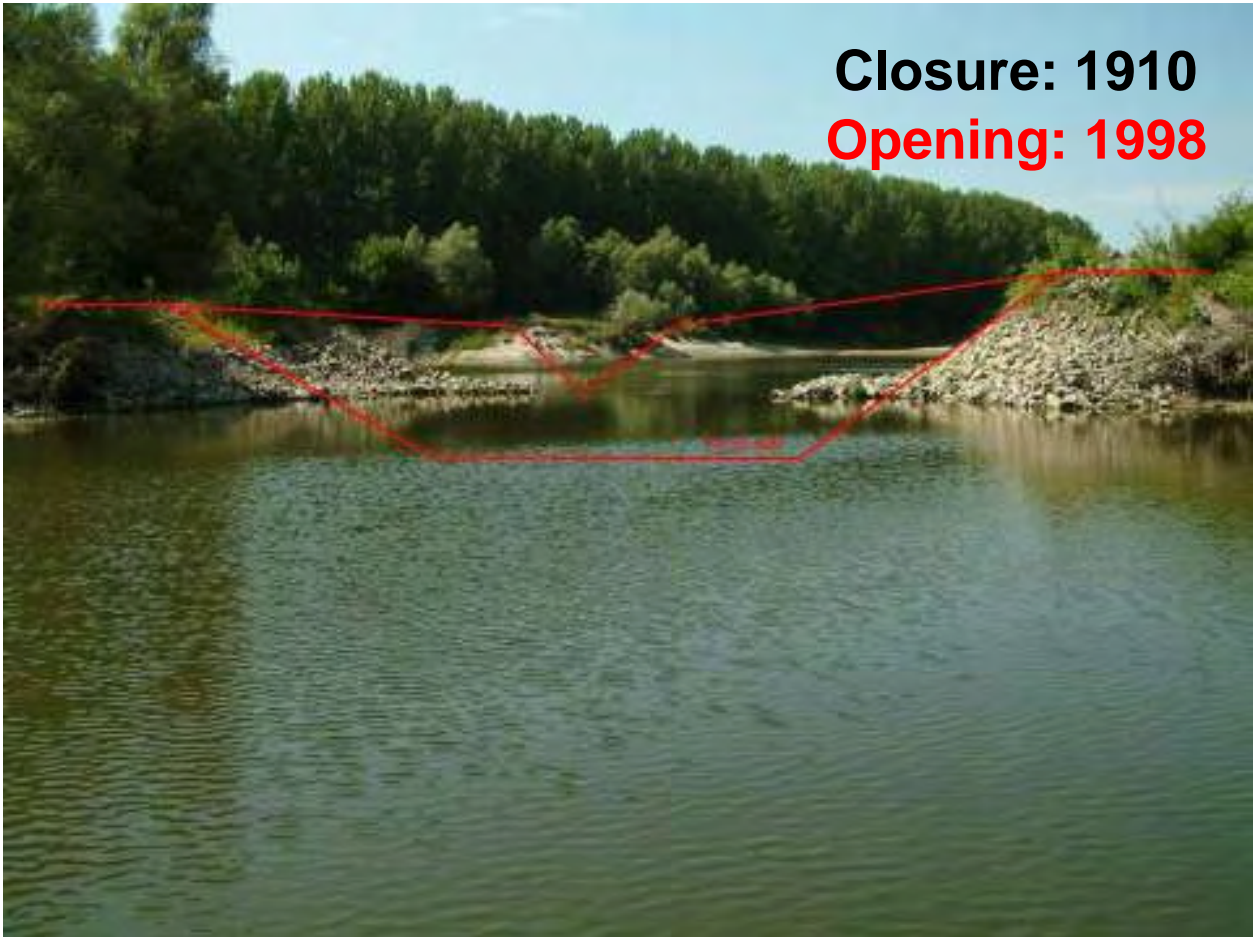
Closure: 1910

Opening: 1998

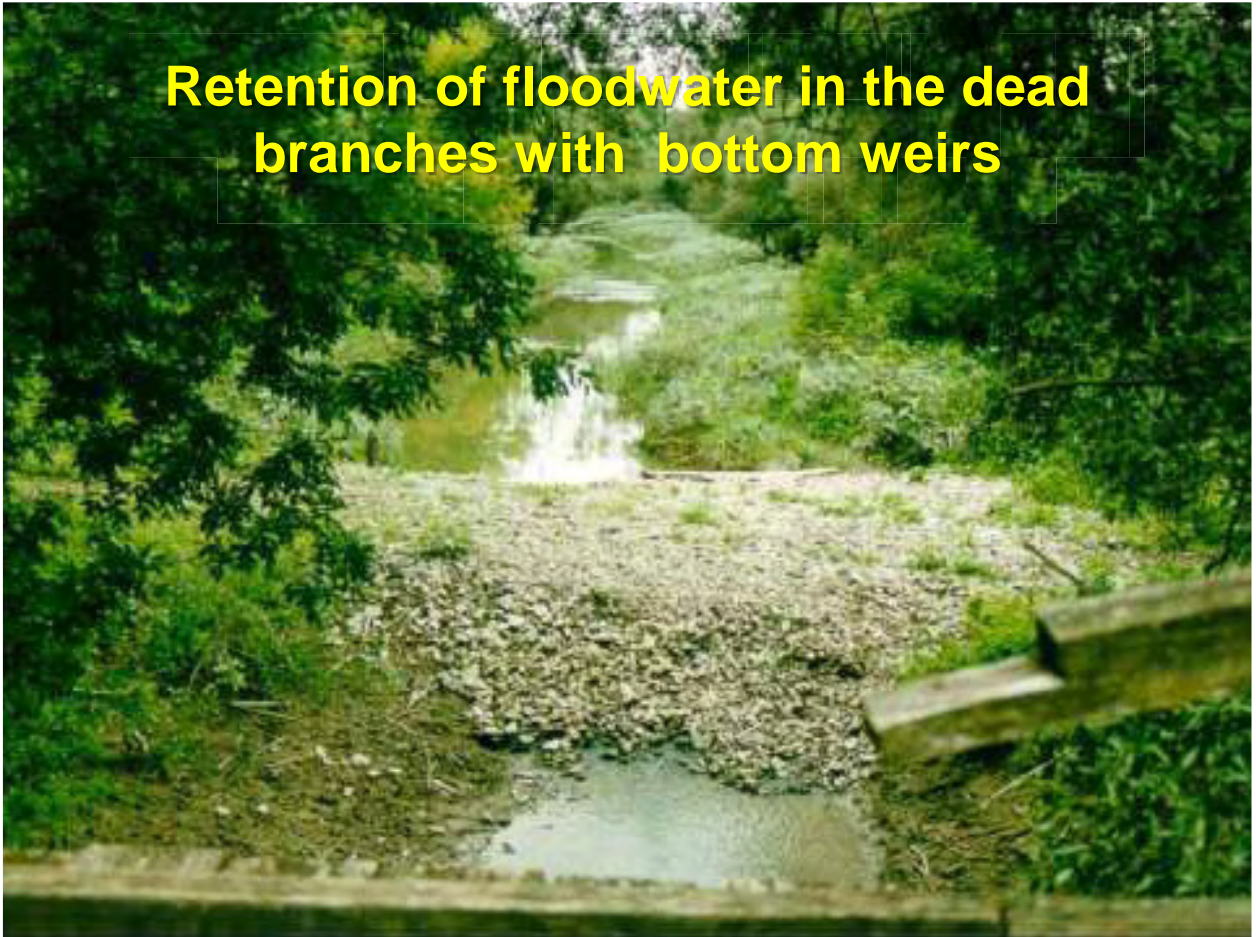
Retention of floodwater in the dead branches with bottom weirs

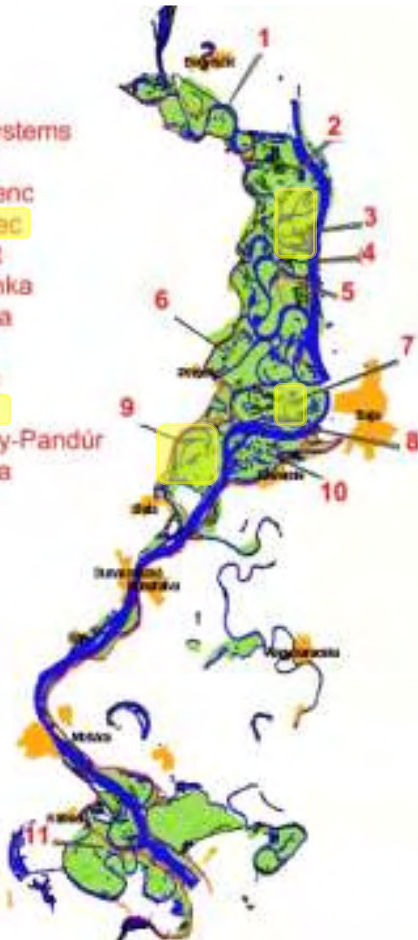
Watersystems

1. Sió
2. Gemenc
3. Grébec
4. Buvat
5. Veránka
6. Cserta
7. Bóli
8. Mőnc
9. Bétai
10. Nagy-Pandúr
11. BÉda

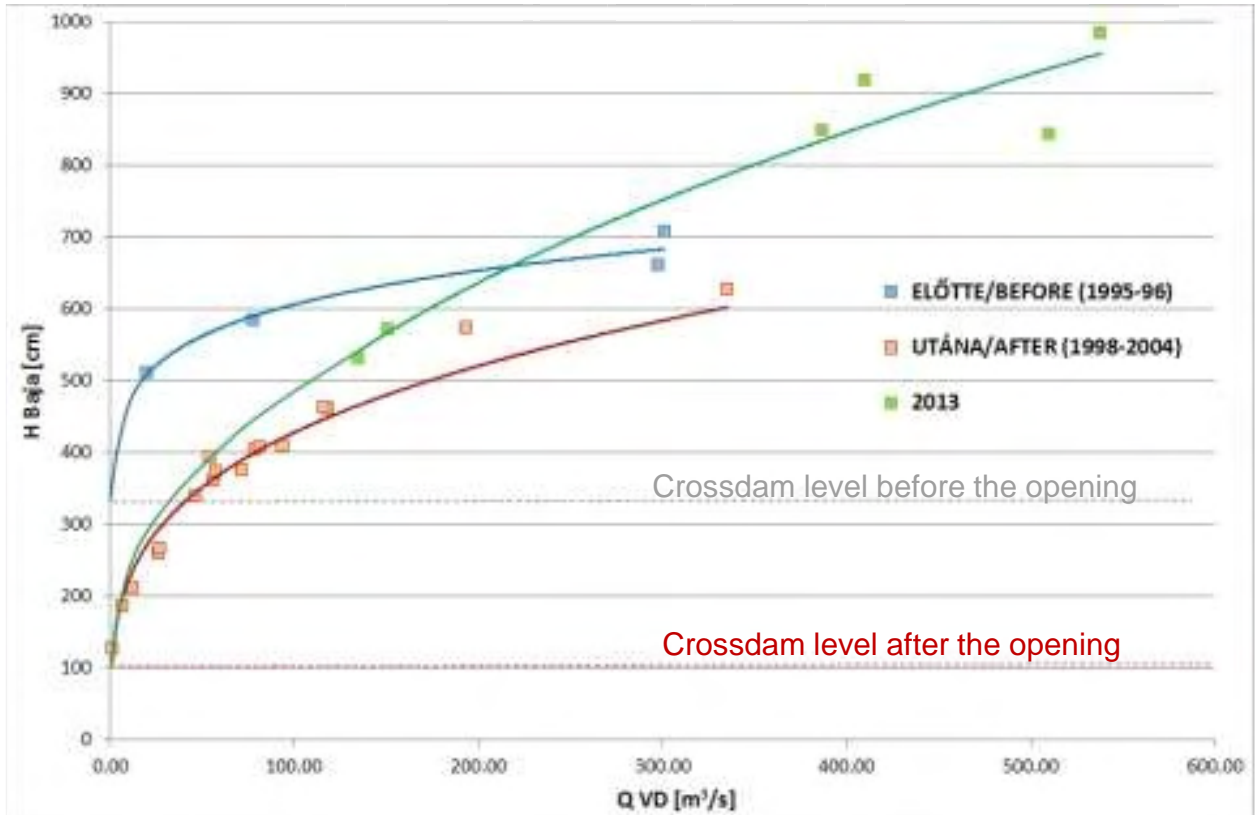
Rating curves of the Vén-Duna branch

Date	BAJA H (cm)	VD Q (m3/s)	Sediment sampling	Measured by	Instrument
1995.06.07	662	298.00		EJF-MF VGT	OTT Nautilus
1995.06.16	708	301.00		EJF-MF VGT	OTT Nautilus
1995.09.12	512	19.90		EJF-MF VGT	OTT Nautilus
1996.05.23	585	77.70		EJF-MF VGT	OTT Nautilus
1998.09.09	340	46.20	Bed and suspended	EJF-MF VGT	OTT Nautilus
1998.09.11	375	71.10		EJF-MF VGT	OTT Nautilus
1998.09.18	462	118.00		EJF-MF VGT	OTT Nautilus
1998.09.22	574	193.00		EJF-MF VGT	OTT Nautilus
1998.10.01	410	94.00		EJF-MF VGT	OTT Nautilus
1999.09.07	404	78.20		EJF-MF VGT	OTT Nautilus
1999.10.13	259	26.40		EJF-MF VGT	OTT Nautilus
1999.10.25	187	6.55	Bed and suspended	EJF-MF VGT	OTT Nautilus
2000.03.13	627	335.00		EJF-MF VGT	OTT Nautilus
2000.08.02	407	80.90		EJF-MF VGT	OTT Nautilus
2000.09.04	212	12.40		EJF-MF VGT	OTT Nautilus
2000.10.02	266	26.60	Bed and suspended	EJF-MF VGT	OTT Nautilus
2002.10.14	393	53.90		EJF-MF VGT	OTT Nautilus
2003.07.16	128	0.76	Bed-load only	EJF-MF VGT	OTT Nautilus

2003.10.12	362	56.00		EJF-MF VGT	OTT Nautilus
2003.10.12	373	57.70		EJF-MF VGT	OTT Nautilus
2004.01.17	463	116.00		EJF-MF VGT	OTT Nautilus
2013.05.11	572	150.57	Bed and suspended	EJF MKK VVI	ADCP RG WH1200
2013.05.19	531	135.10	Bed and suspended	EJF MKK VVI	ADCP RG WH1200
2013.06.08	843	510.00		ADUVIZIG	ADCP RG WH600
2013.06.13	985	538.00		ADUVIZIG	ADCP RG WH1200
2013.06.16	918	410.00		ADUVIZIG	ADCP RG WH600
2013.06.18	849	387.00		ADUVIZIG	ADCP RG WH600
